HELICOPTER ICING SPRAY SYSTEM (HISS) EVALUATION AND IMPROVEMENTS

APRIL 1986

FINAL REPORT

UNITED STATES ARMY AVIATION ENGINEERING FLIGHT ACTIVITY
EDWARDS AIR FORCE BASE, CALIFORNIA 93523

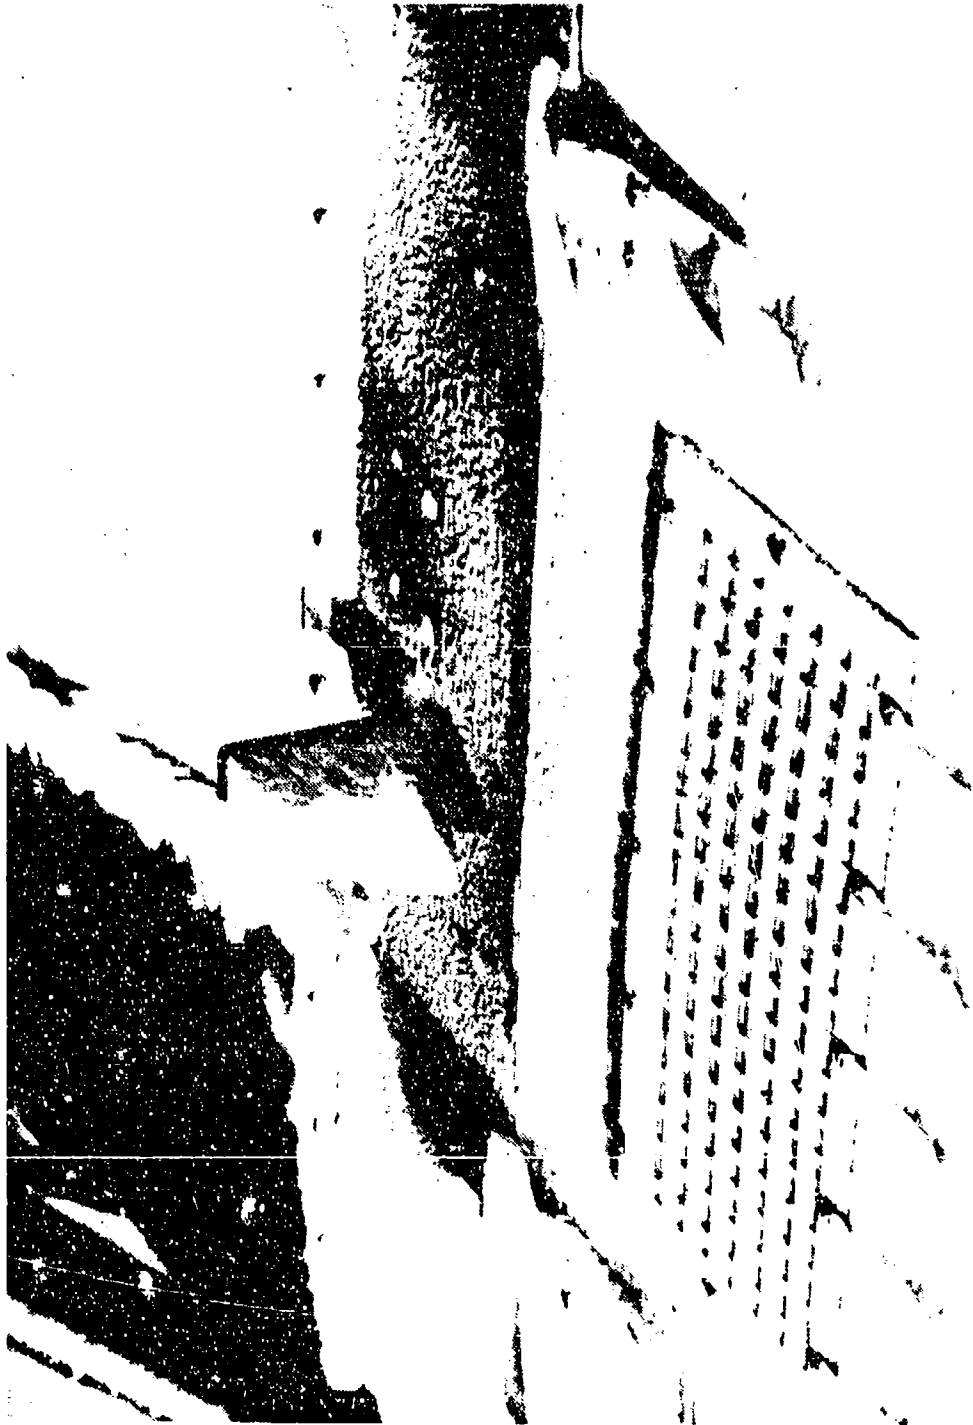
Photo 24. Artificial (HISS) Ice. Area Forward of Center Windshield (UH-60)

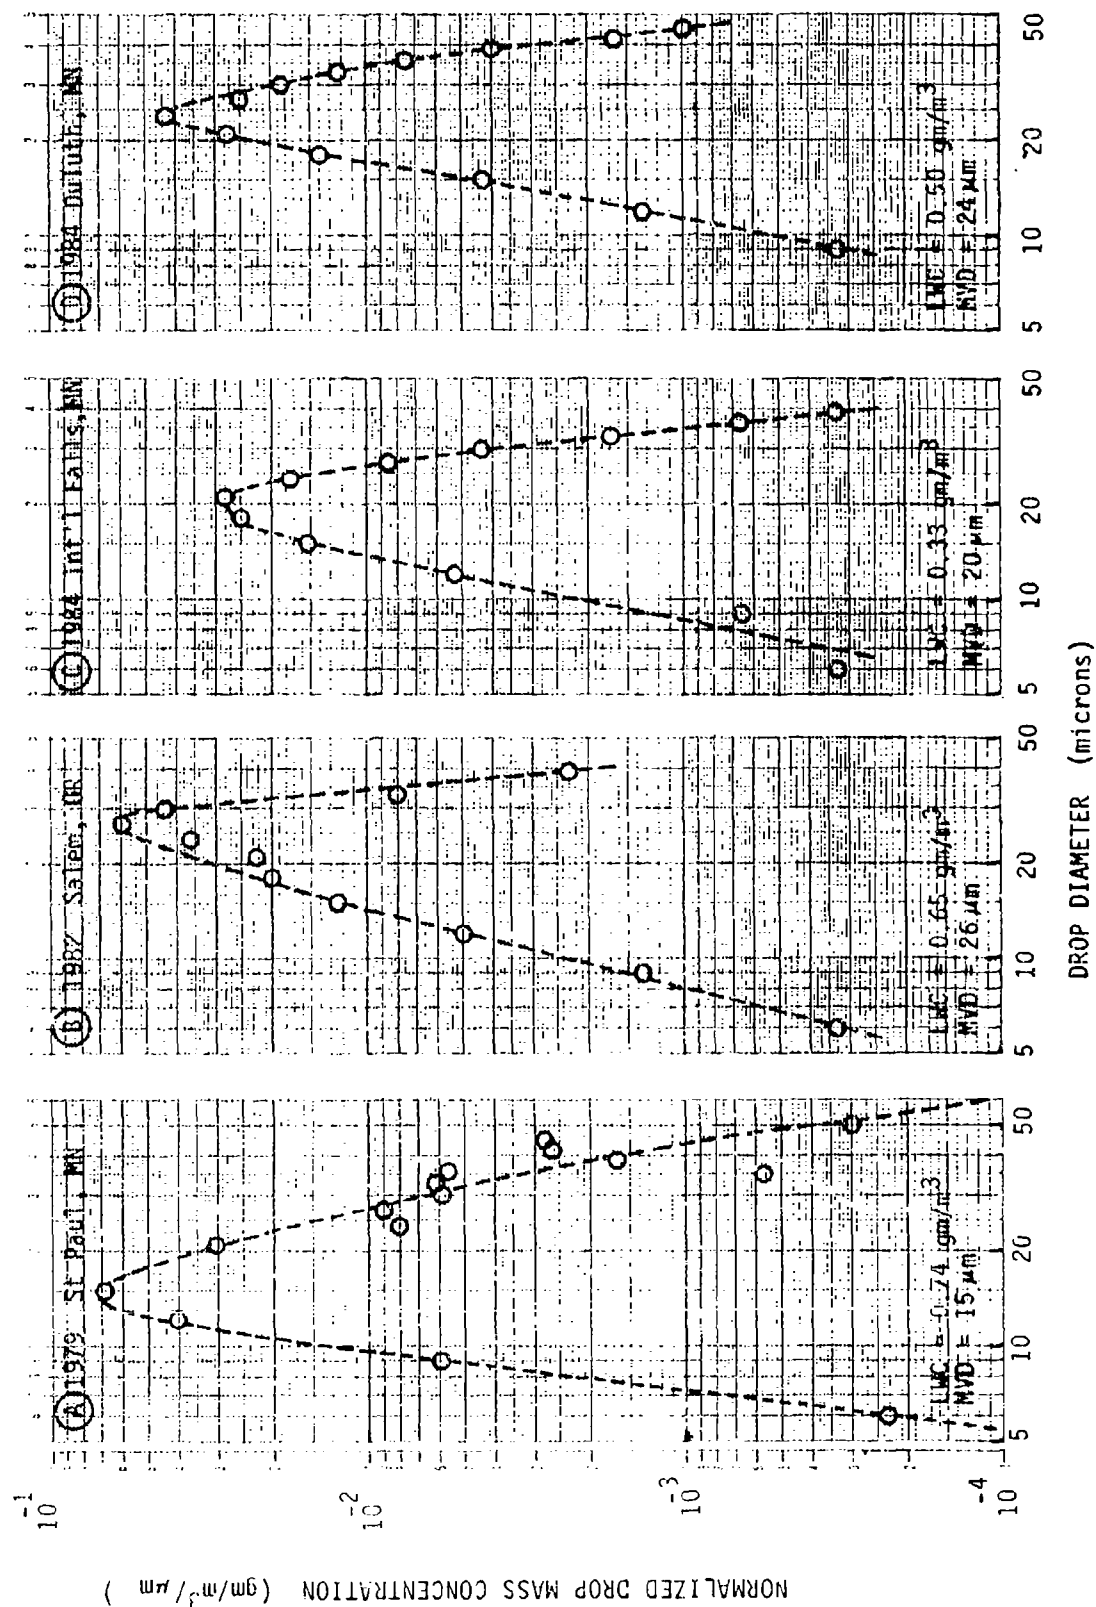
FIGURE 1
NATURAL STRATIFORM CLOUD
DROP MASS DISTRIBUTIONS

NOTE: Data obtained using Particle Measuring Systems, Inc. laser spectrometers

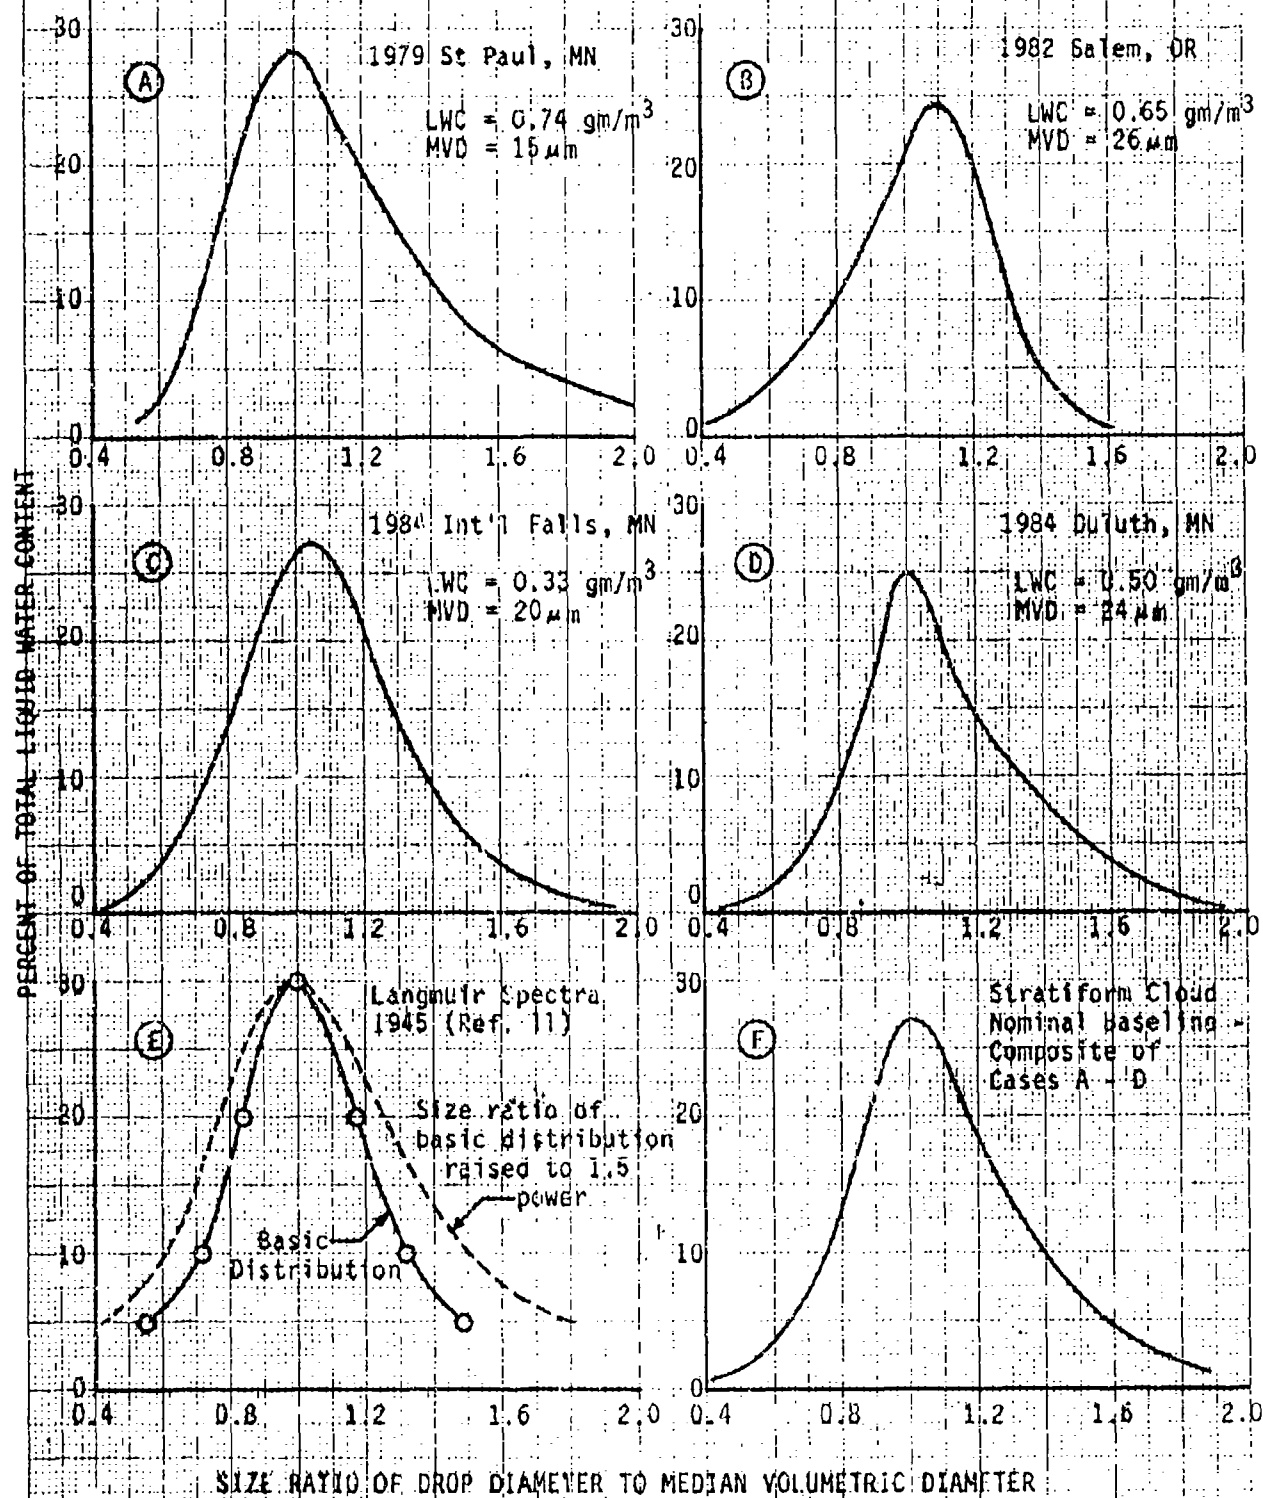
FIGURE 2
NATURAL STRATIFORM CLOUD
NONDIMENSIONAL DROP
MASS DISTRIBUTIONS

NOTE: Natural Cloud Distributions A - D Taken From Fig. 1

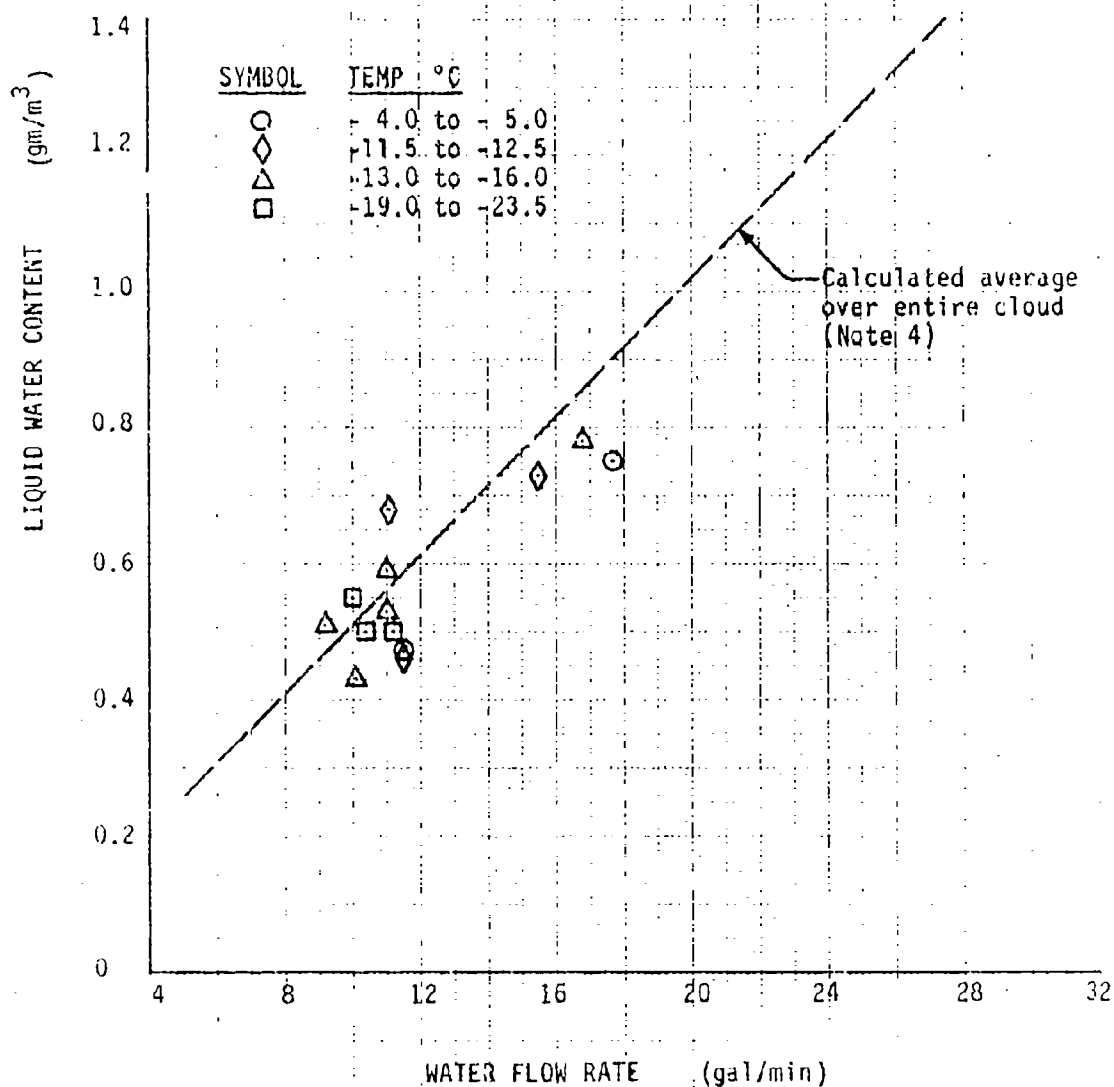
FIGURE 3
WATER FLOW RATE AND LIQUID
WATER CONTENT OF HISS SPRAY CLOUD

- NOTES: 1. 97 Sonicore nozzles installed on trapeze sections only
2. Data obtained using Particle Measuring Systems, Inc laser spectrometers
3. Measurements taken during stable immersions centered in spray cloud 180 ft behind spray boom
4. Line shows calculated average for 8 x 36 ft cloud cross section at 90 KTAS (Para 21)
5. Airspeed = 90 KTAS

over intervals lasting from 10 to 20 seconds selected from approximately one minute long stable immersions in the spray cloud. The LWC measurements (figs. 3 and 4) can be compared with the "calculated average" linear function (para 22) shown for each airspeed. The degree of agreement with the calculated line and the range of scatter are typical of those observed previously (refs 3 and 4, app A). The MVD data (figs. 5 and 6, app F) are taken from the same cloud samples and fall in a range between 34 and 75 μ m. For comparison, the 1980 results (ref 3, app A) showed a high concentration of data between 20 and 35 μ m, and the 1982 data (ref 4) ranged from 25 to 40 μ m MVD at flow rates below 13 gal/min, and 40 to 70 μ m at higher flow rates. While overlap exists with the previous range of values, the present MVD data tend to group toward the upper end of the size range. Even at low flow rates where the finest atomization should occur, no MVD's averaged below 34 μ m. This undesirable indication of larger drop sizes than seen in the past tends to shift the artificial cloud spectrum away from the nominal 15 to 25 μ m MVD range typically attributed to natural clouds. In view of the otherwise enhanced flow distribution characteristics of the spray system that were expected to improve atomization, this discrepancy cannot be readily explained. With some uncertainty in data quality introduced by instrumentation problems (para 27), substantive conclusions regarding any change of atomization performance cannot be drawn.

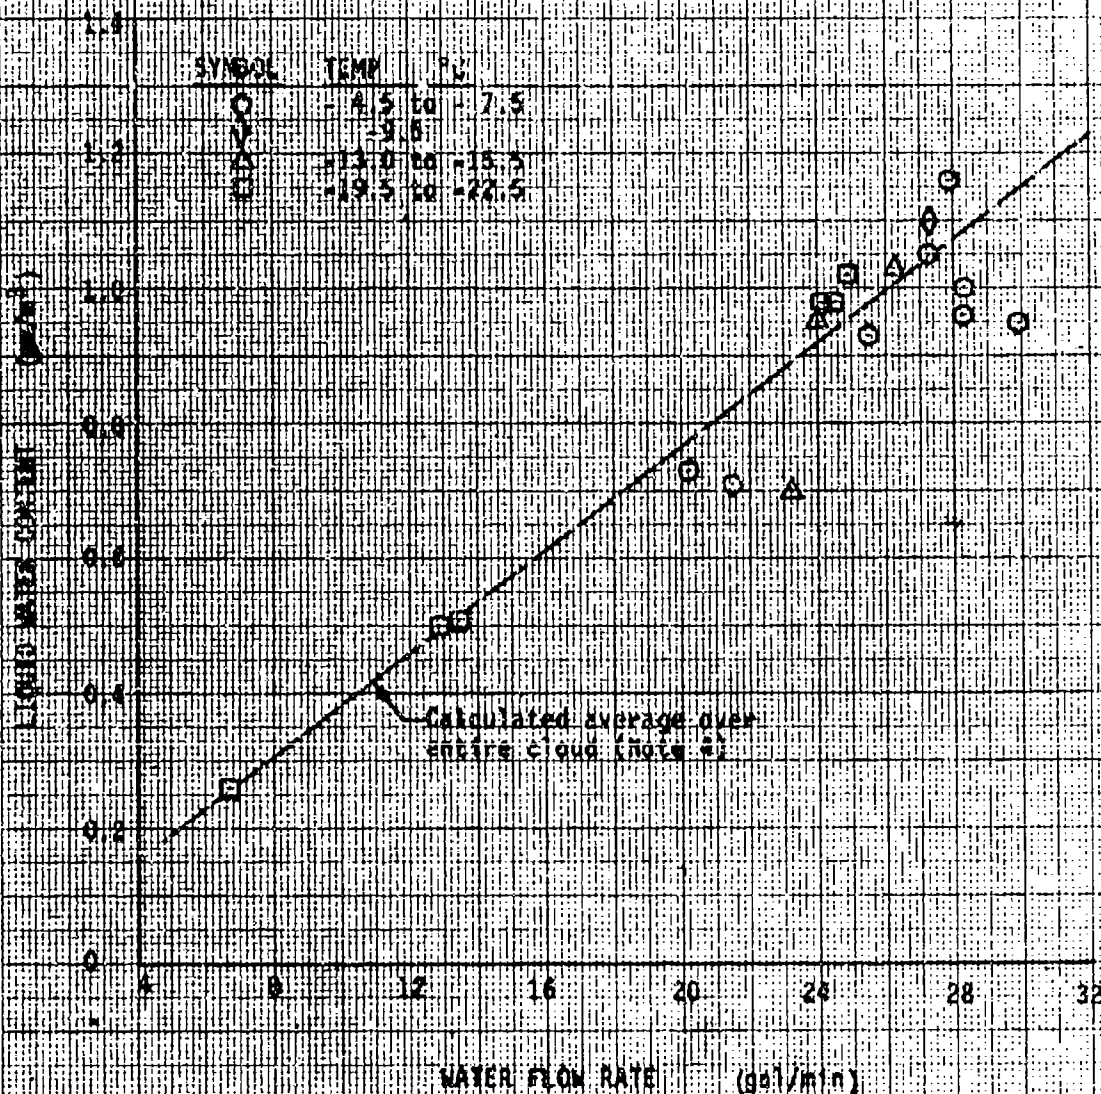
FIGURE 4
WATER FLOW RATE AND LIQUID
WATER CONTENT OF HISS SPRAY CLOUD

- NOTES: 1. 57 Sensors were installed on trapeze sections only.
2. Data obtained using Particle Measuring Systems, Inc. laser spectrometers.
3. Measurements taken during stable immersions centered in spray cloud 180 ft. behind spray booms.
4. Line shows calculated average for 8 x 36 ft cloud cross section at 120 KIAS (Para 21).
5. Airspeed = 120 KIAS.

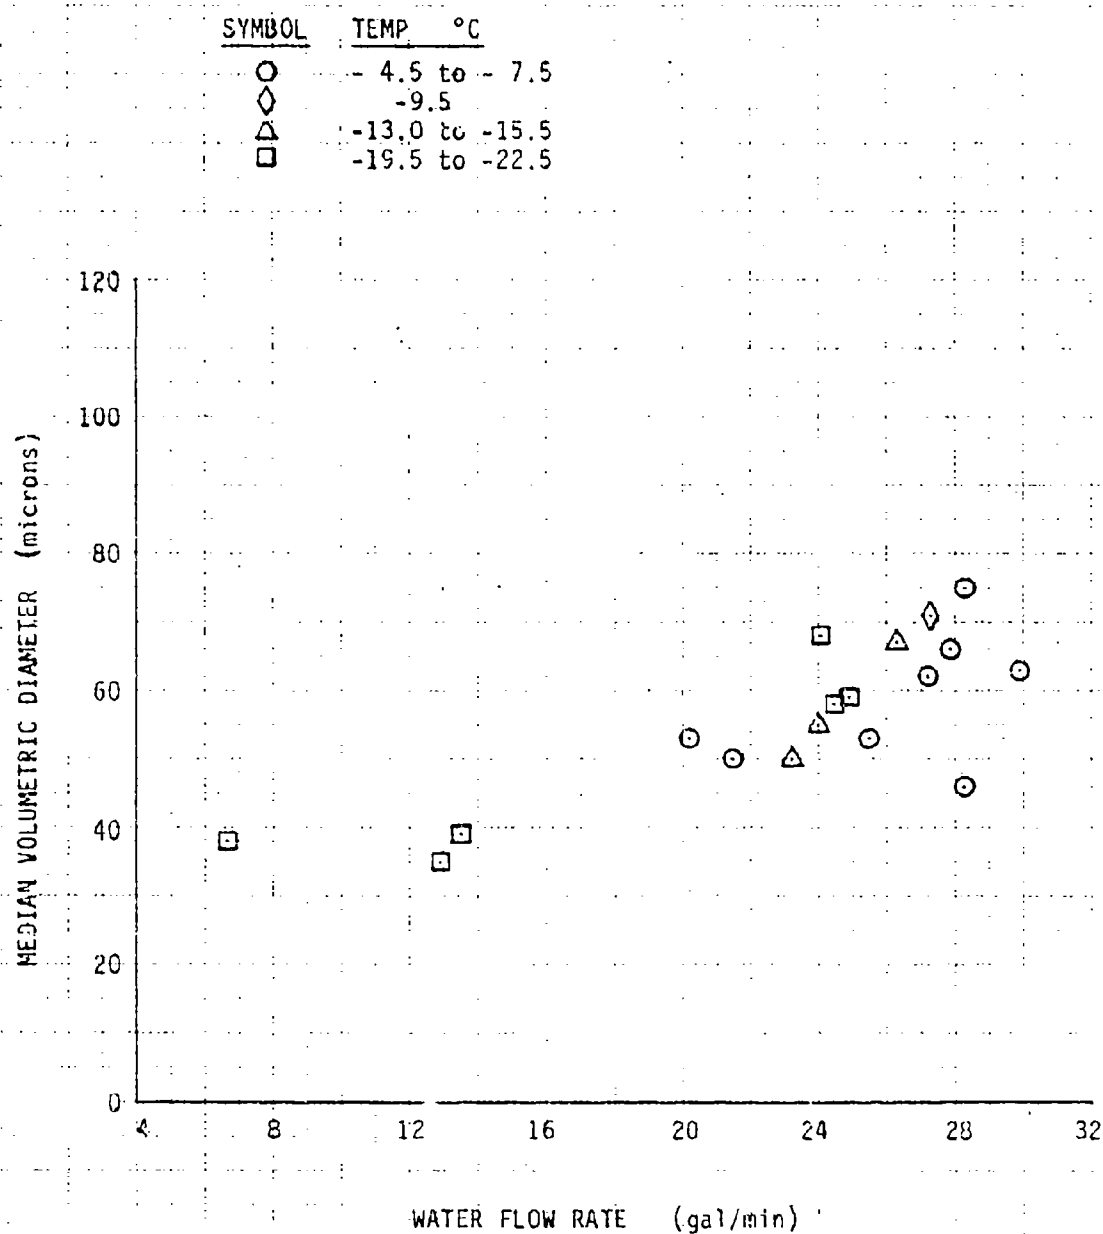
FIGURE 7
HELICOPTER ICING SPRAY SYSTEM
DROP MASS DISTRIBUTIONS

- NOTES: 1. 97 Sonicore nozzles installed on trapeze sections only
2. Data obtained using Particle Measuring Systems, Inc. laser spectrometers
3. Measurements taken 180 ft. behind spray booms

29. Examples of normalized spray cloud drop spectra are presented in figure 7, appendix F. For comparison with previous HISS data, case A is taken from reference 3, appendix A and shows a sample from 1980 with an MVD of 21 μ m. Cases B and C are from 1984 with MVD's of 35 and 55 μ m, respectively. These data were obtained from "cloud centered" samples and are one second records selected as representative of the average conditions. When compared with the natural cloud spectra of figure 1, appendix F differences are evident in slope and in shape near the apex. While the peak concentrations occur at reasonable values of drop size (15 to 25 μ m), the HISS distributions are considerably broader and include larger drop sizes above 50 μ m that do not normally occur in natural clouds. This is particularly evident at higher flow rates as in case C. Presence of these larger drops drives the MVD upward.

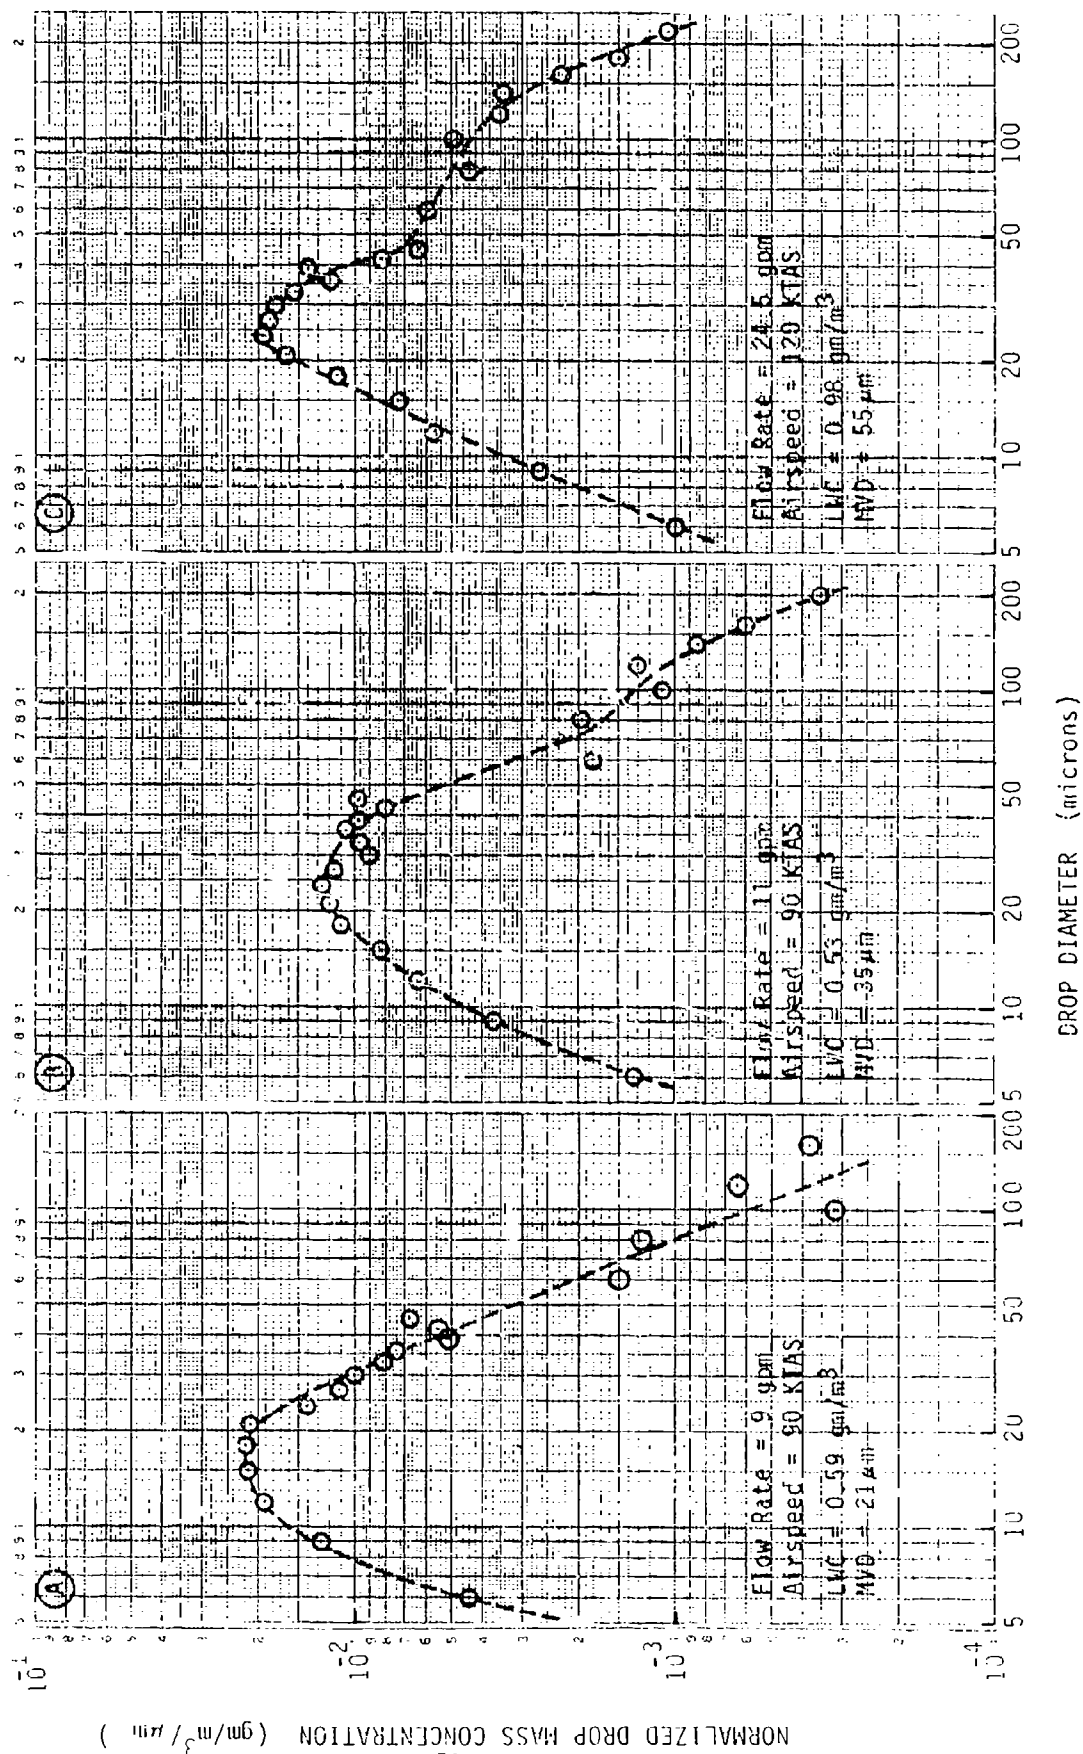
FIGURE 8
HELICOPTER ICING SPRAY SYSTEM
NONDIMENSIONAL DROP
MASS DISTRIBUTIONS

NOTES: 1. 97 Sonicore nozzles installed on trapeze sections only
2. Artificial cloud distributions taken from Fig. 7

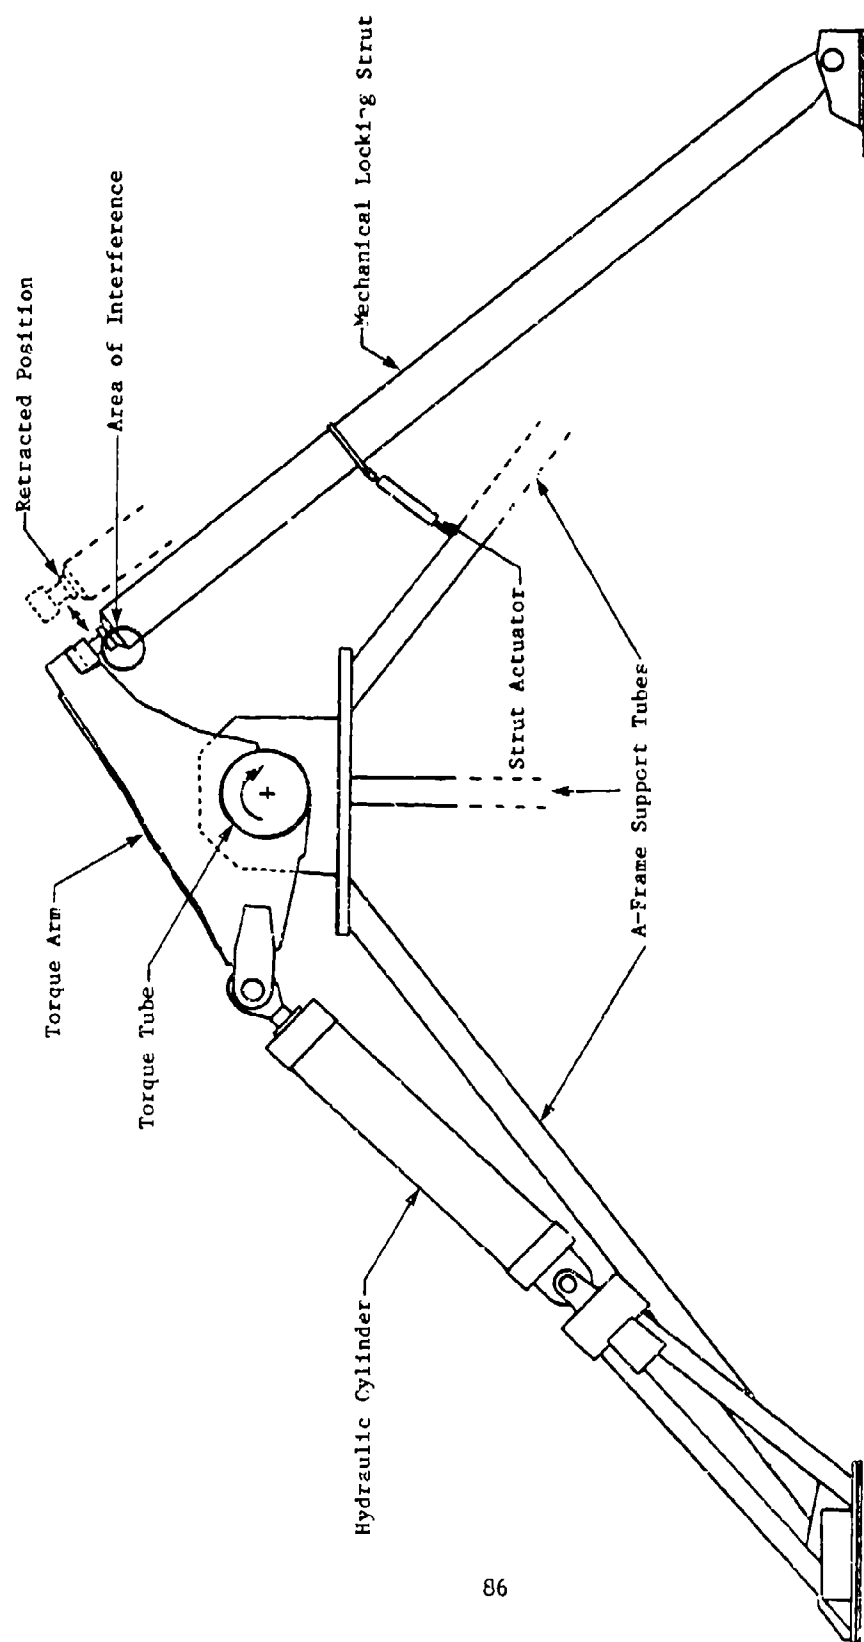
Figure 1. Torque Tube and Trunnion Mount Assembly

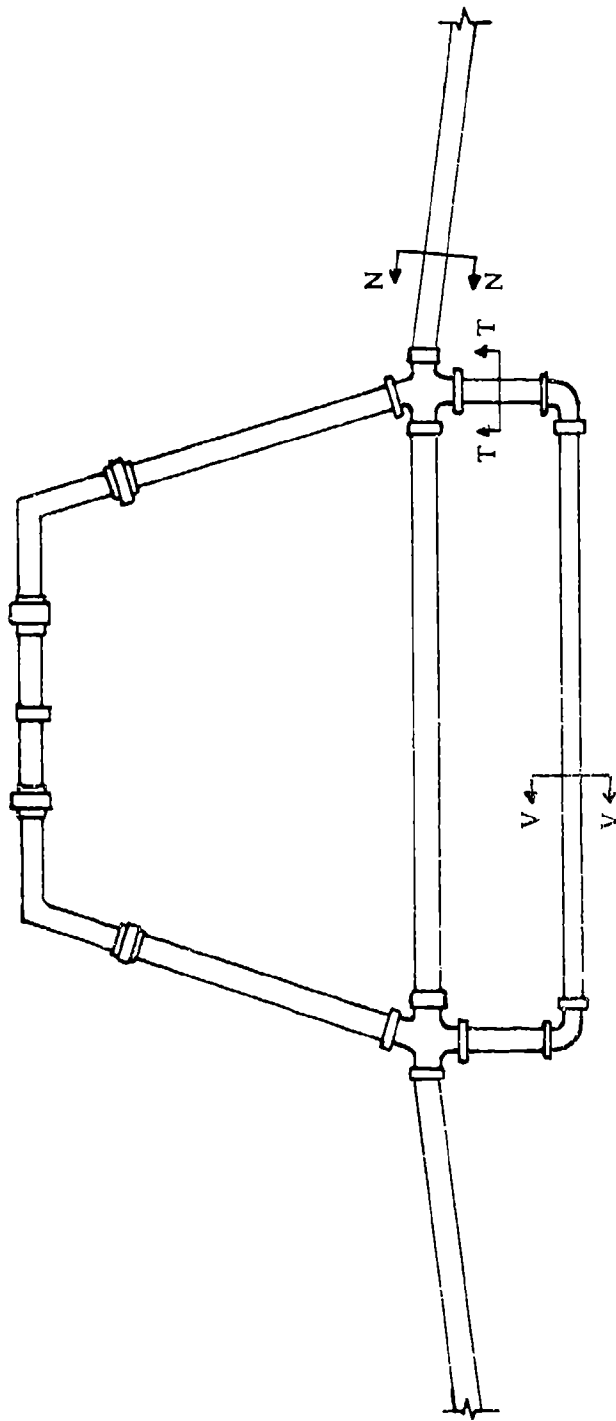
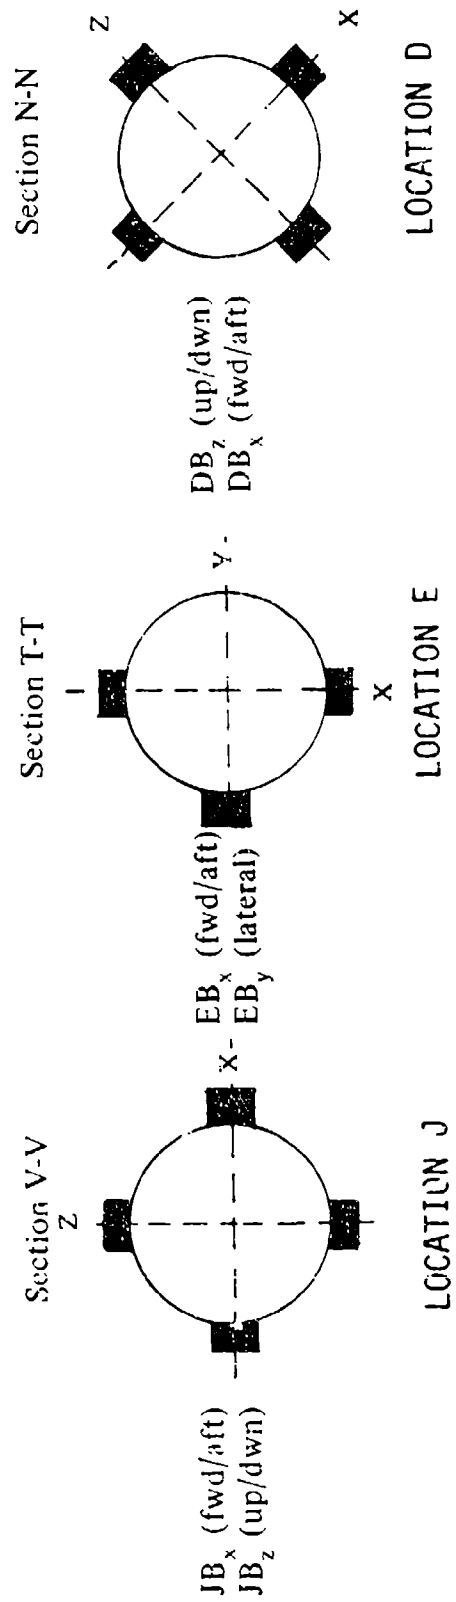
Figure 1. Spray Boom Instrumentation Schematic

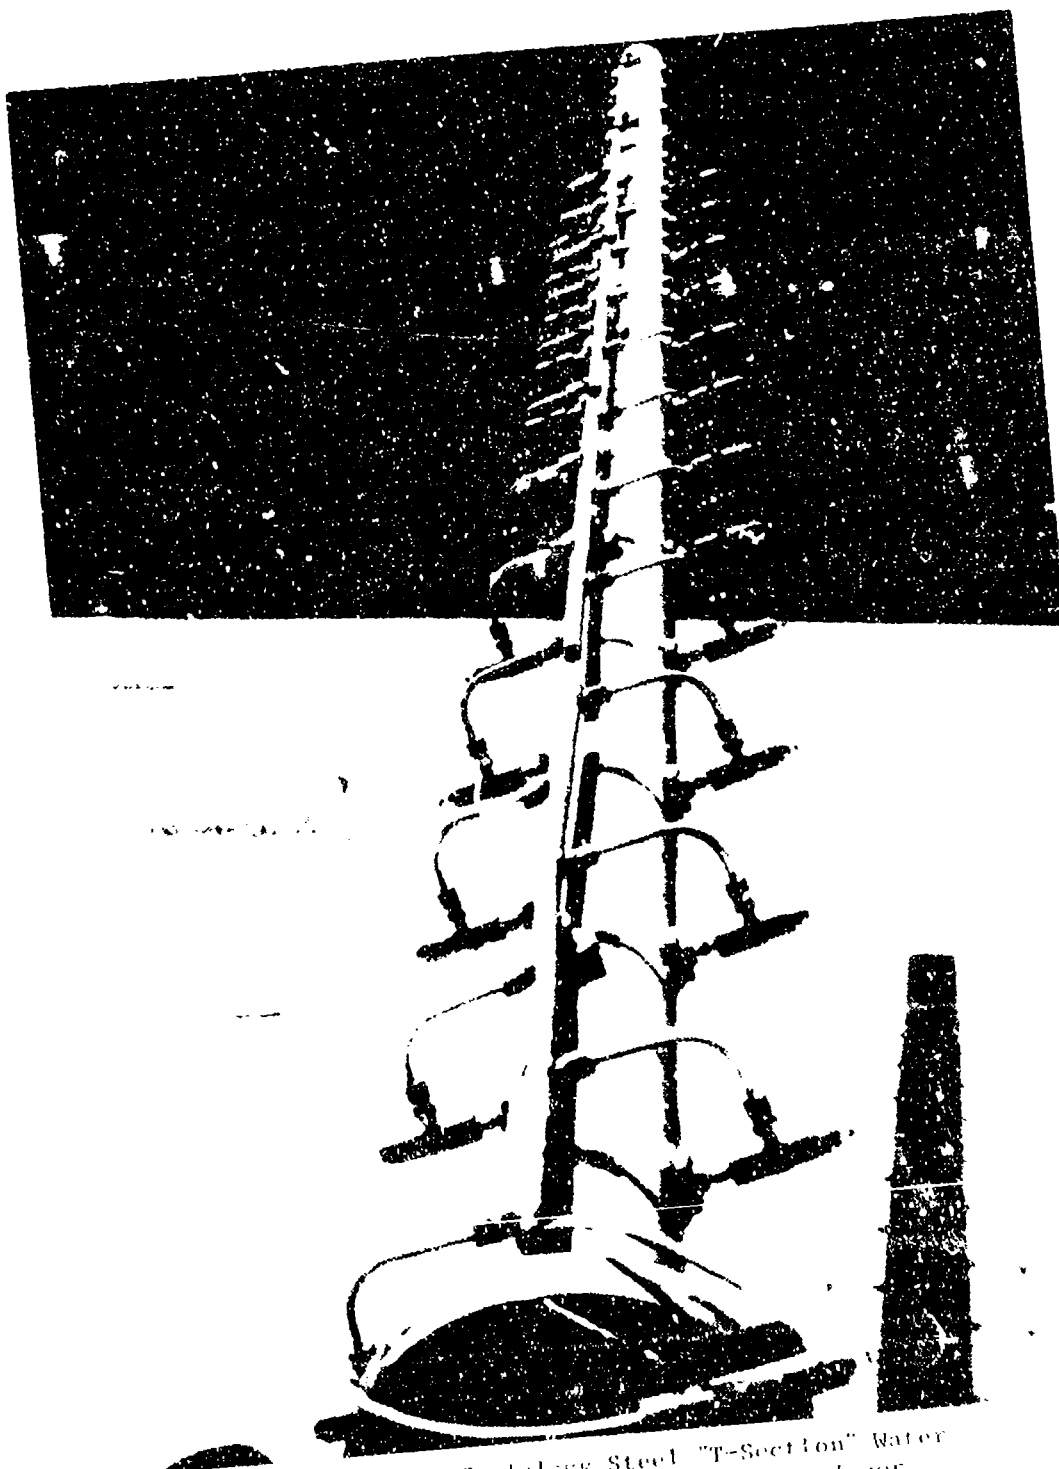
Photo 1. Stainless Steel "T-Section" Water
Manifold. Installed on Left Outrigger

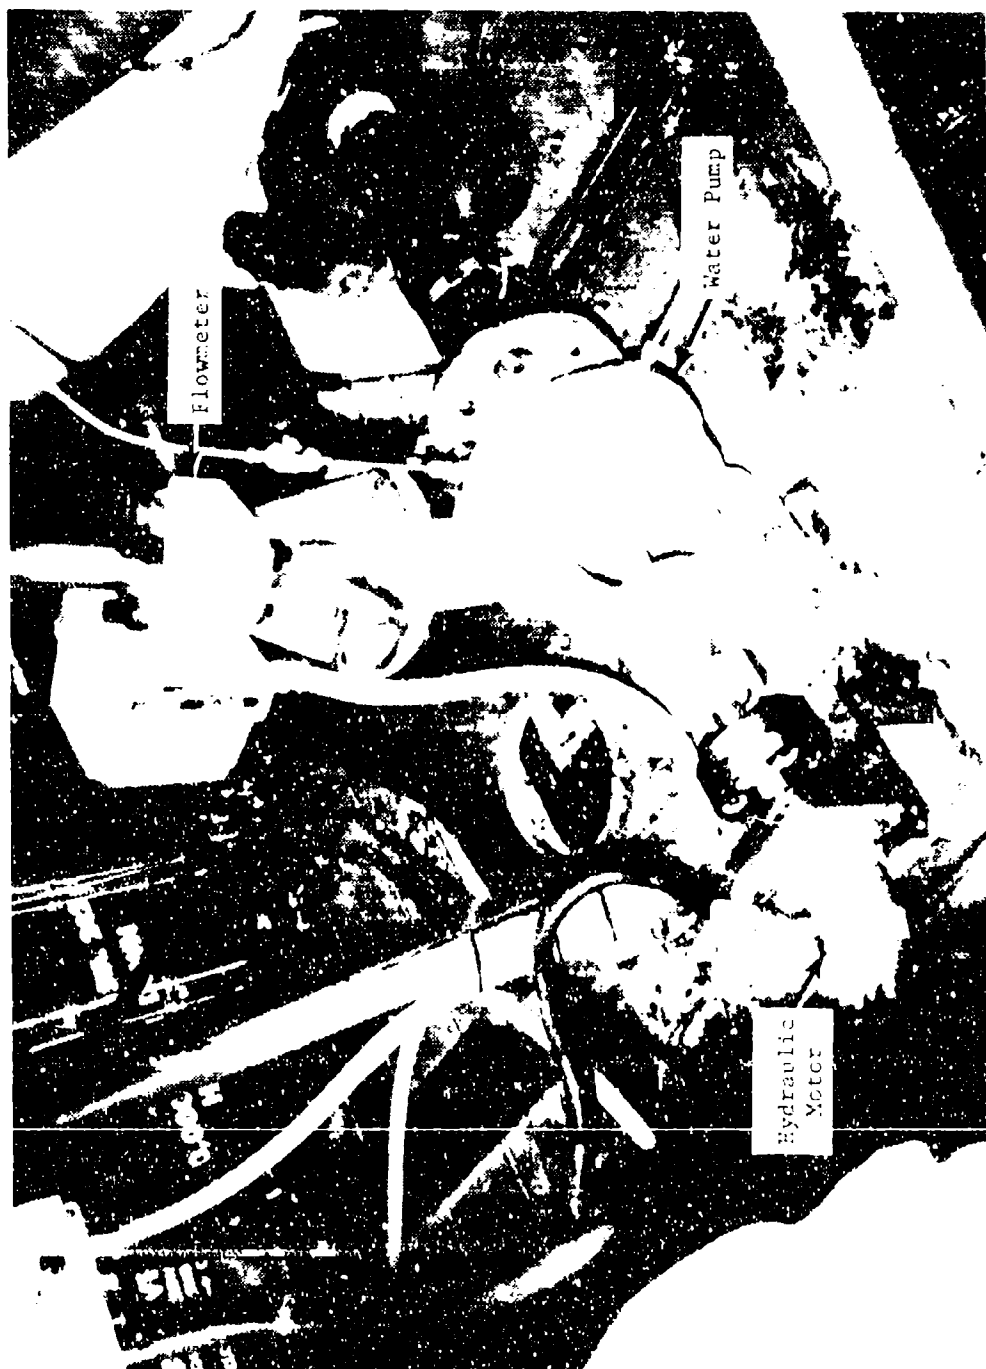
Photo 2. Water Pump and Flowmeter

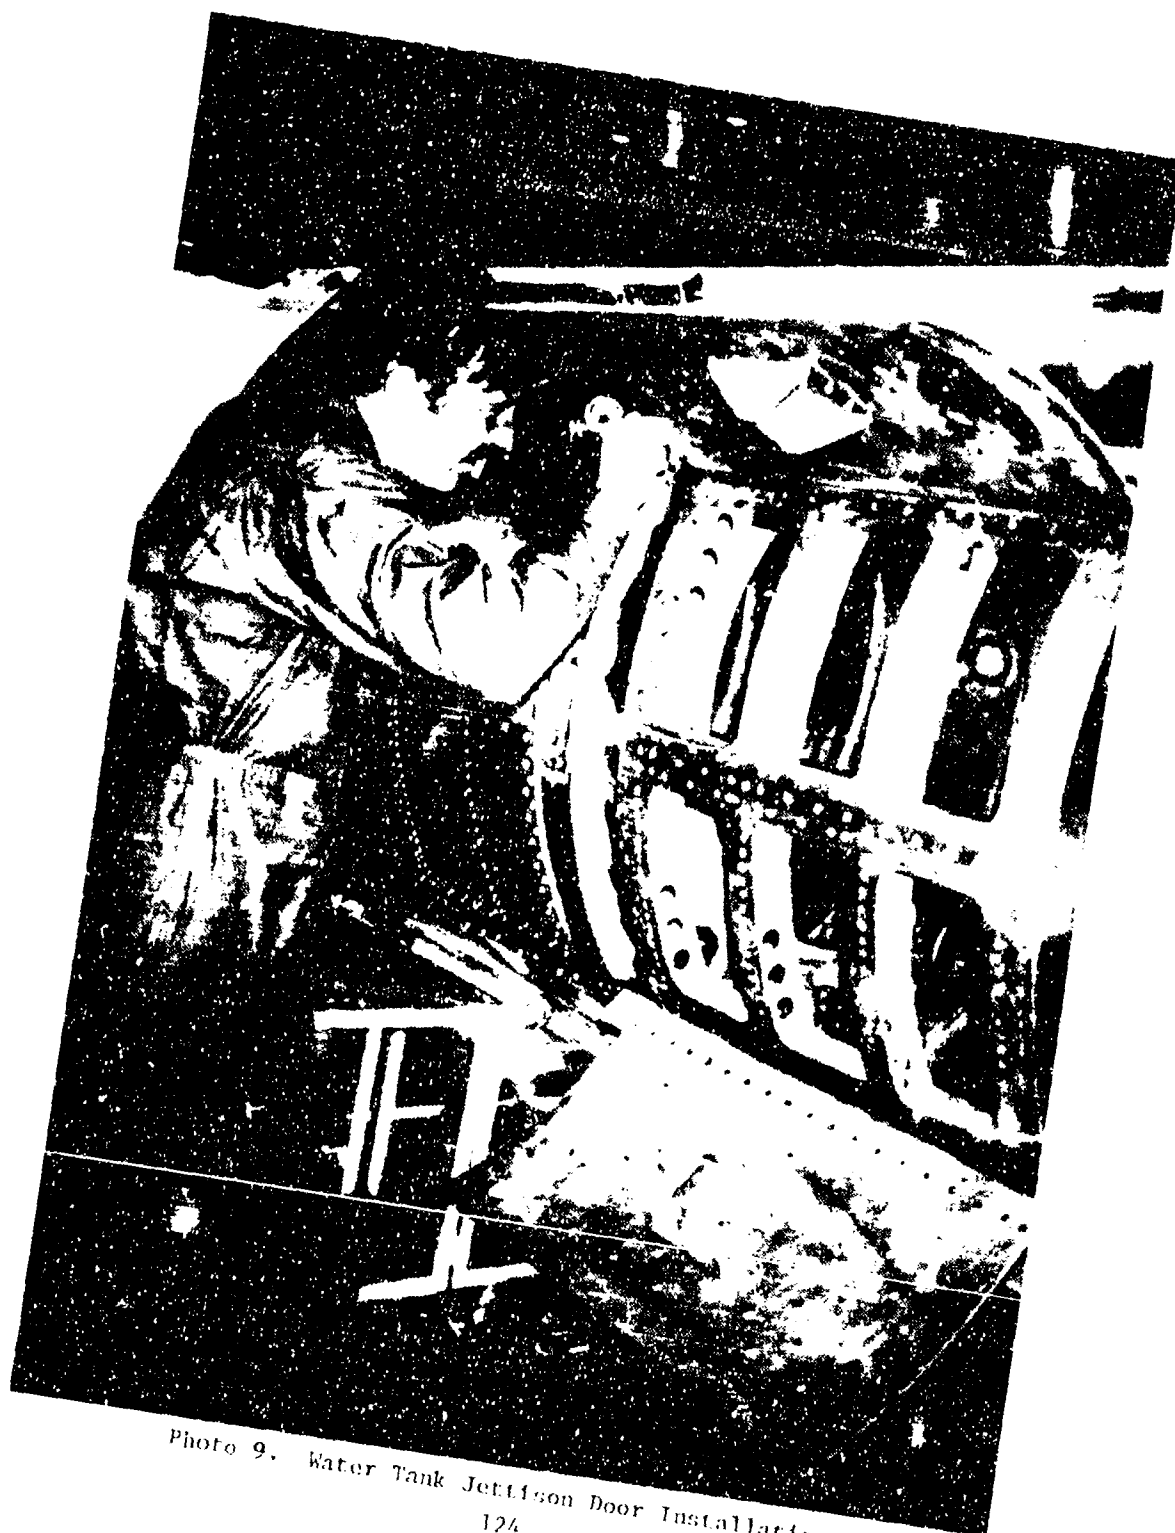
Photo 9. Water Tank Jettison Door Installation

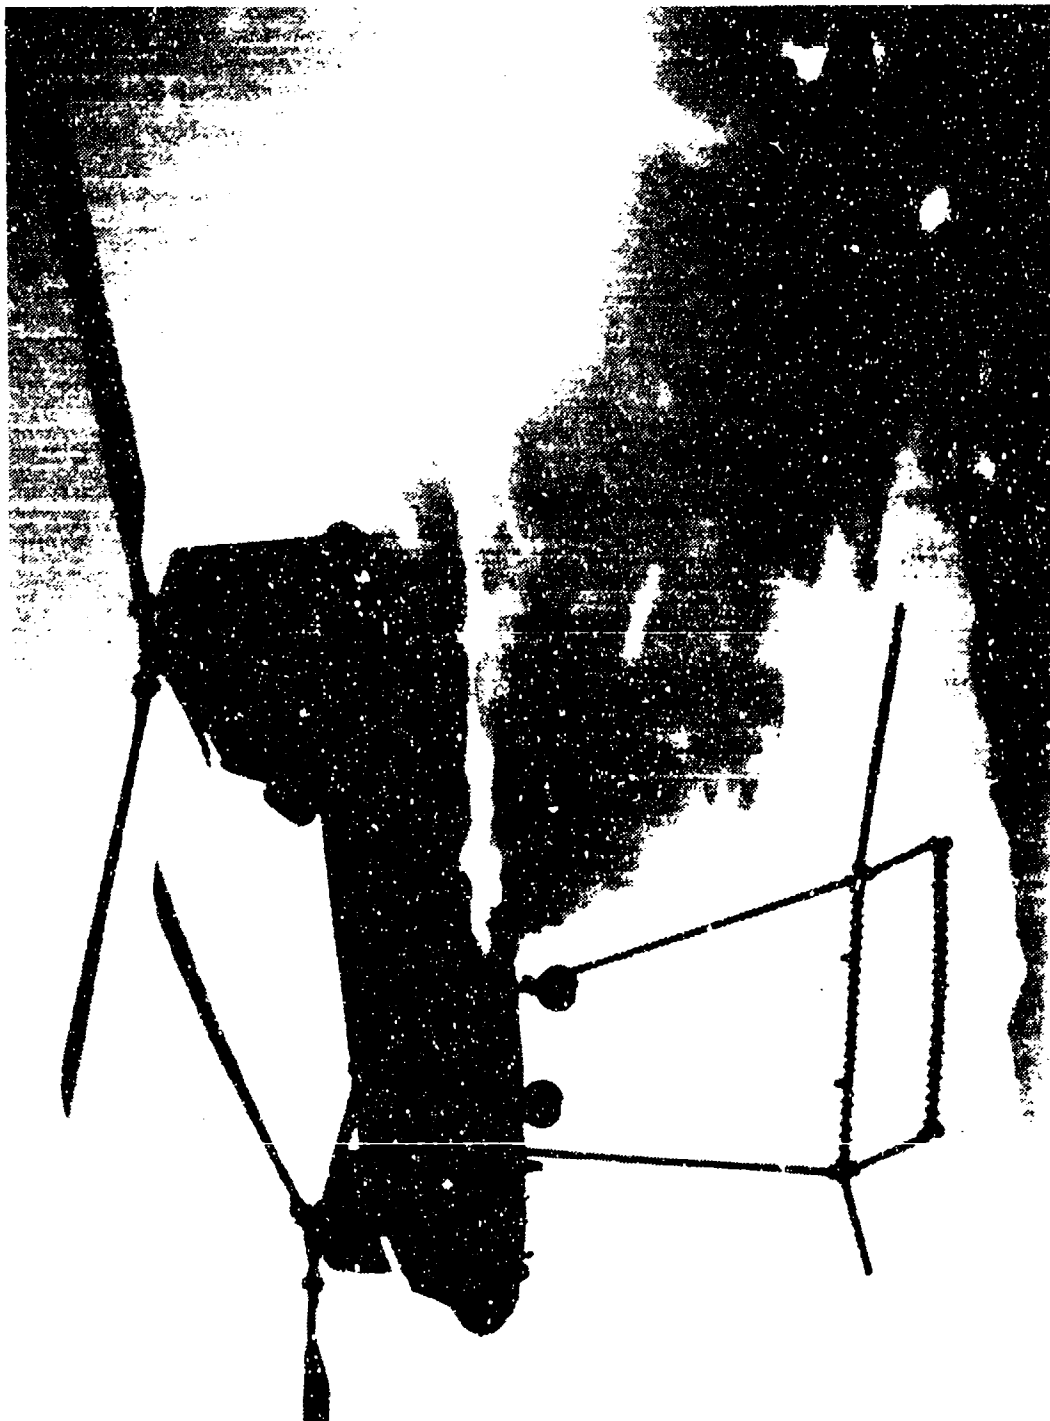
Photo 14. Water Jettison Test in Level Flight at 107 KIAS
